Inspection Report

1234 Main St.
Auburn WA 98002

Coastline Home Inspections

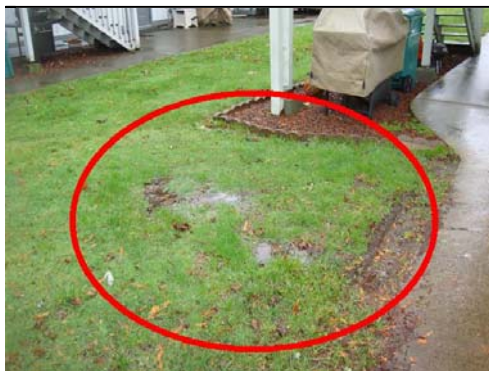
1.0 Repair/Replace: The soil was very soggy and standing water was noted at several locations along the left and rear of the property. Recommend further evaluation and the installation of additional drainage or repairs to subsurface drainage as needed by a licensed contractor to prevent standing water and ensure that yard is usable through the winter months.

1.0 Item 1(Picture) Ponding water

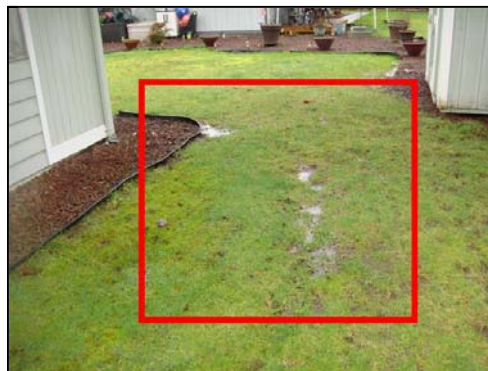
1.0 Item 2(Picture) Ponding water

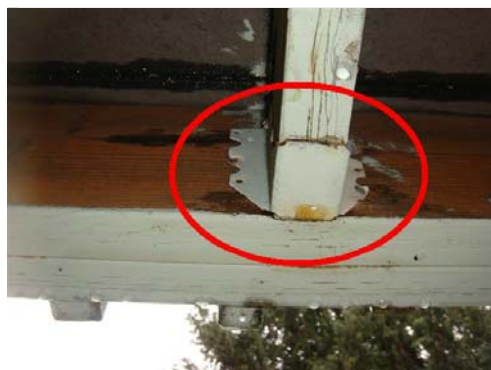
1.1 (2) Repair/Replace: Safety : Inadequate fasteners were noted on many joist hangers at the front deck. According to the manufacturer, fasteners are required at all holes supplied by the manufacturer of the bracket. Also, screws were being used on brackets at several locations. Screws are not permitted to be used at these locations as they do not contain the same shear strength as a nail. Also, wood rot was noted on several floor joists of this deck. Newer pressure-treated wood has been sistered to the rotting portions however, wood rot will continue to grow and eventually begin to damage the pressure-treated lumber. The top of the stair stringers are beginning to pull loose creating a fall hazard. It is recommended that a licensed contractor familiar with deck construction be contacted to make repairs to the deck and stairs, making all repairs to current industry standards to prevent accidental injury.

1.1 Item 2(Picture) Example of fasteners needed

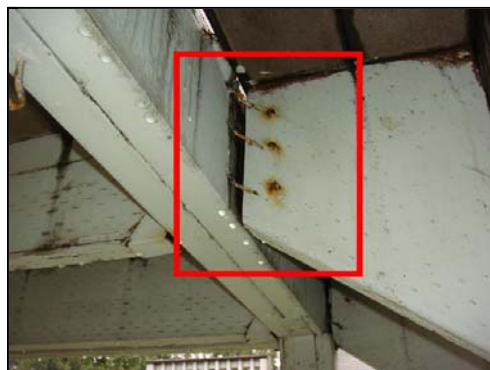
1.1 Item 5(Picture) Stair stringer pulling loose

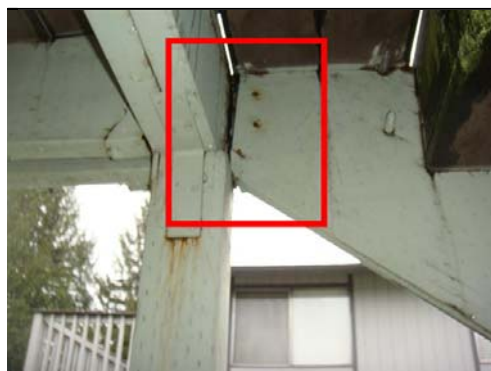
1.1 Item 6(Picture) Stair stringer pulling loose

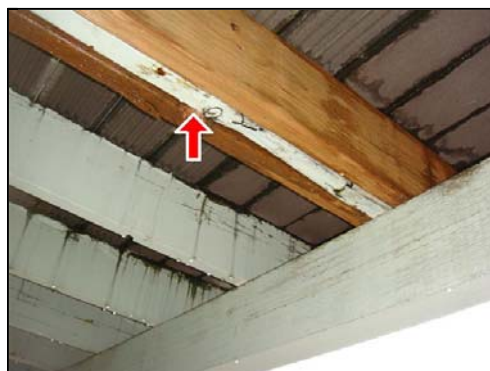
1.1 Item 7(Picture) Wood rot

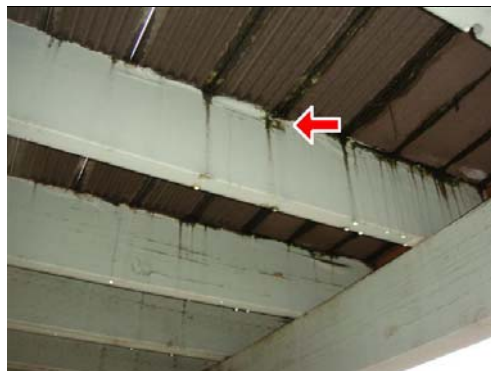
1.1 Item 8(Picture) Wood rot

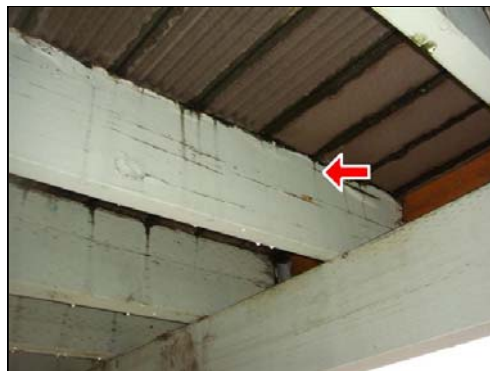
1.1 Item 9(Picture) Wood rot

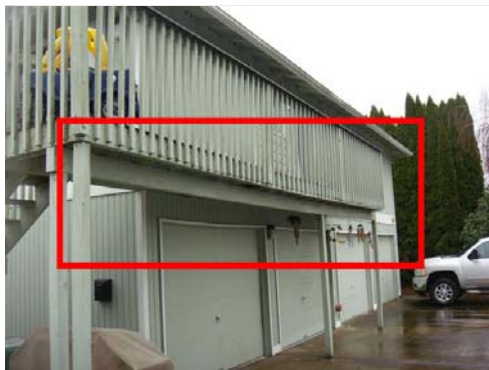
1.1 Item 10(Picture) Location needed fasteners

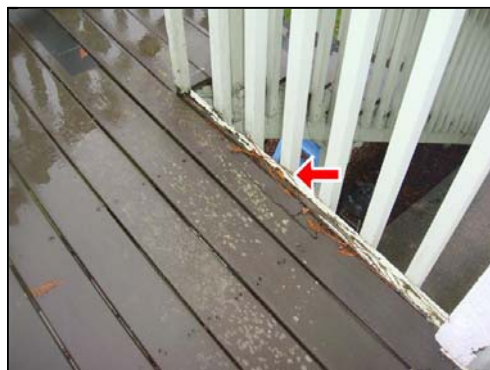
1.1 Item 13(Picture) Wood rot

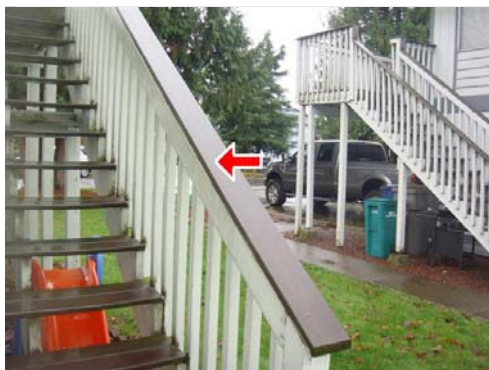
1.1 (3) Maintenance: The handrail on the front stairs were improper. It is recommended that a graspable handrail be installed that is no greater than 6.25" in diameter be installed at this location.

1.1 Item 14(Picture) Improper handrail

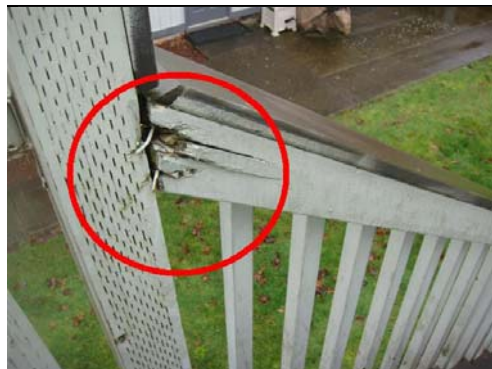
**1.1 (5) Safety :** The top of the handrail is pulling loose on the exterior stairs. Recommend repairs or replacing the handrail by a licensed contractor.

1.1 Item 16(Picture) Damaged handrail

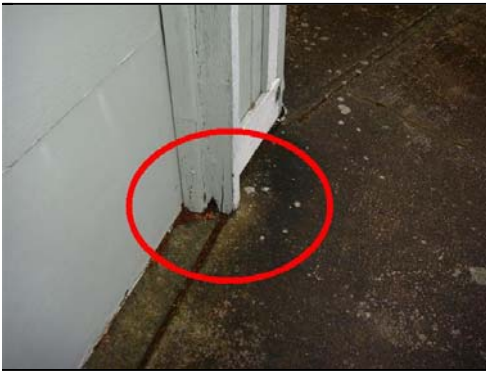
2.0 (1) Repair/Replace: Wood Destroying Organism (WDO): Wood rot was noted on trim and wall cladding at many locations around the perimeter of the home (see photos). Also, the trim was in need of paint at many locations. A board by board inspection is outside the scope of a home inspection however, it is recommended that a licensed siding contractor replace all damaged areas noted in the report and a complete inspection of the exterior of the building, including potentially removing belly band boards between levels of the home and along the ground floor, replacing any damaged siding that may be discovered, prepping, priming and painting the exterior siding and trim as needed. Damaged siding was also noted at all three chimney flashings. When damage occurs at these locations, water intrusion may occur around the chimney flashings.

2.0 Item 3(Picture) Wood rot

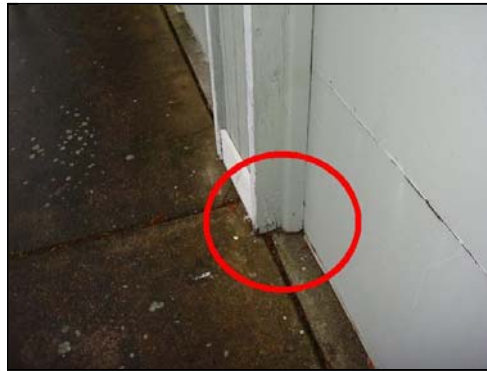
2.0 Item 4(Picture) Wood rot

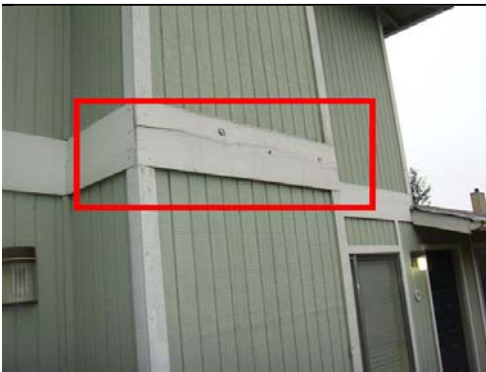
2.0 Item 5(Picture) Split trim

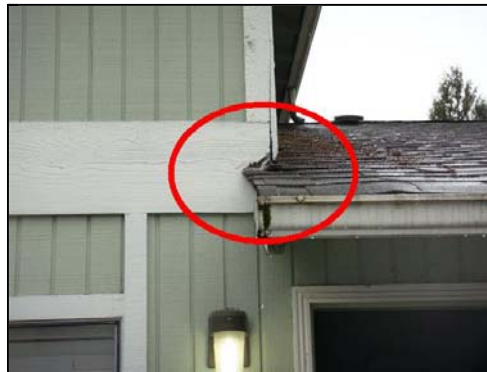
2.0 Item 6(Picture) Wood rot

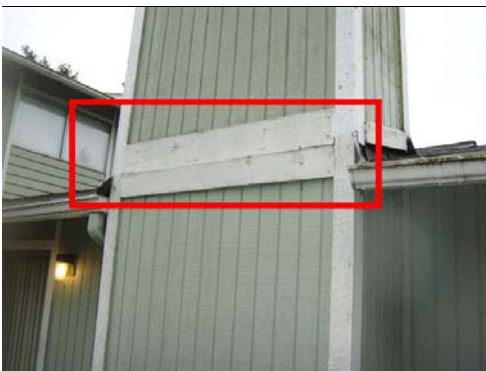
2.0 Item 7(Picture) Split trim

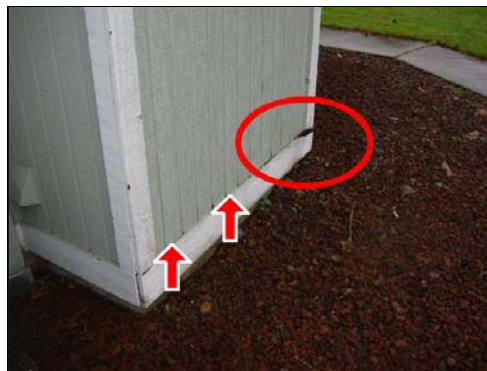
2.0 Item 8(Picture) Wood rot

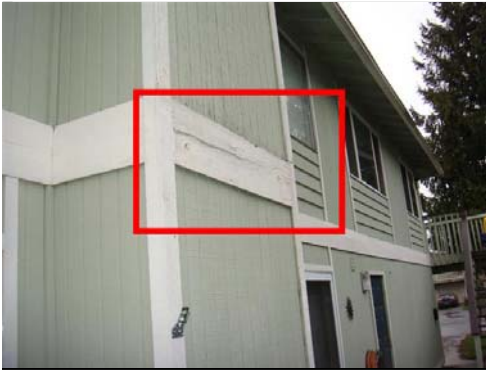
2.0 Item 9(Picture) Split trim

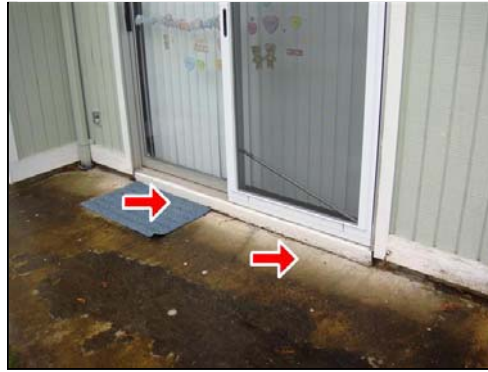
2.0 Item 10(Picture) Wood rot

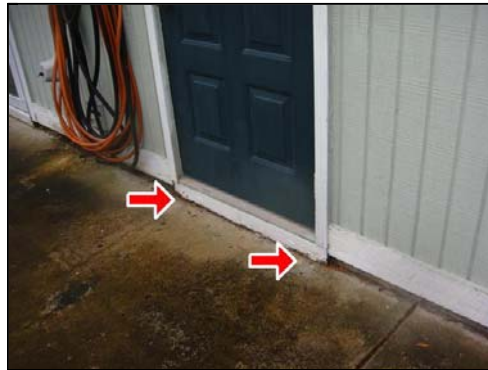
2.0 Item 12(Picture) Wood rot

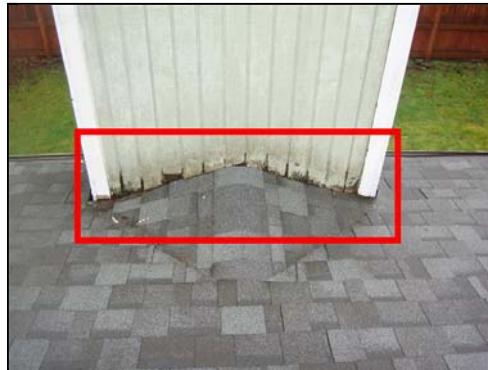
2.0 Item 14(Picture) Damaged siding

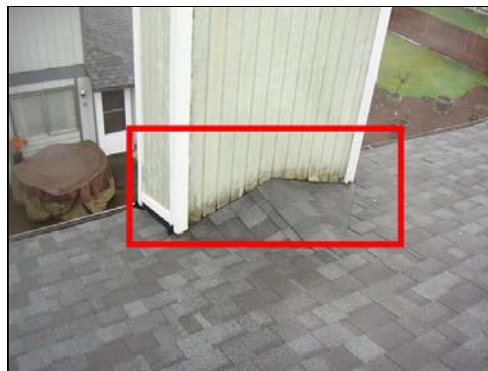
2.0 Item 16(Picture) Wood rot

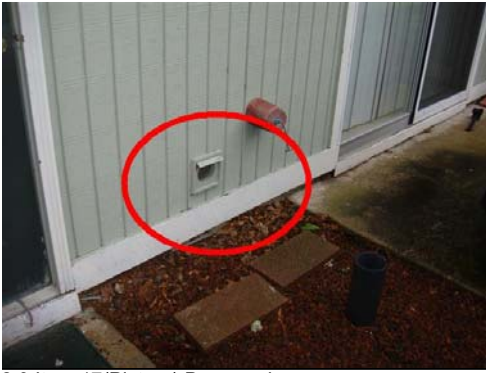
2.0 (2) Maintenance: Louvered dryer duct covers were damaged at the left and right sides of the building. Recommend installing new covers to prevent pest intrusion.

2.0 Item 17(Picture) Damaged cover

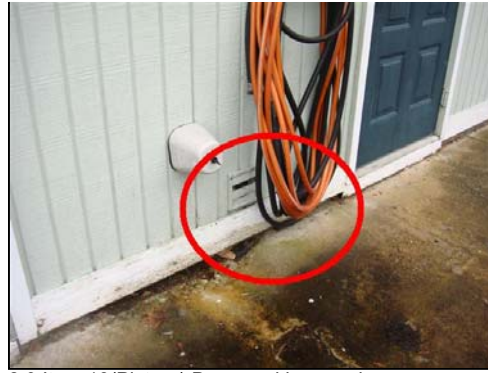
2.0 Item 18(Picture) Damaged louvered cover

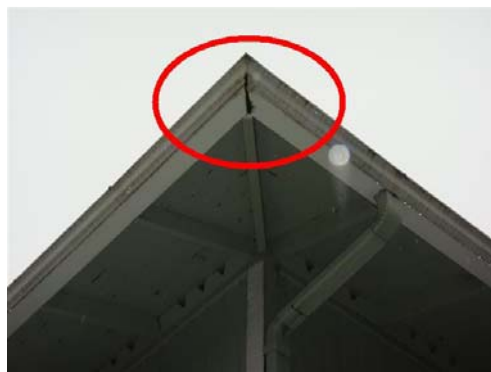
4.3 (1) Repair/Replace: Wood Destroying Organism (WDO): Gutters and downspouts were sagging, leaking and full of water/improperly sloped at many locations around the building. It is recommended that a licensed gutter contractor be contacted to install new gutters on the building to prevent further sagging and damage to the fascia boards and wall cladding of the home.

4.3 Item 1(Picture) Example of leaking gutter

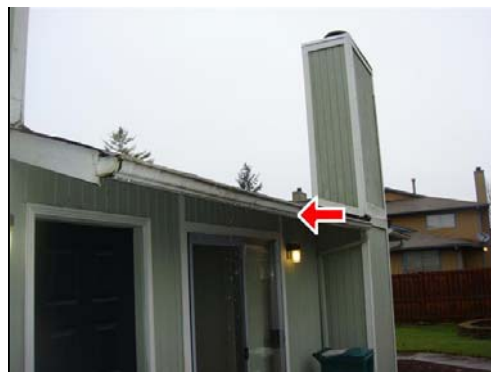
4.3 Item 2(Picture) Water overshooting the gutter

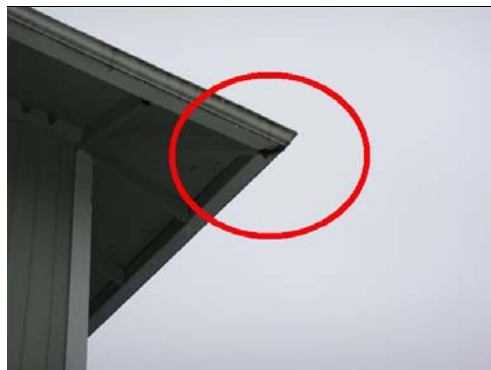
4.3 Item 3(Picture) Example of leaking gutter

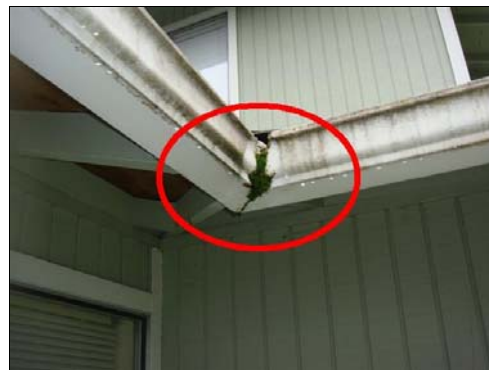
4.3 Item 5(Picture) Example of leaking gutter

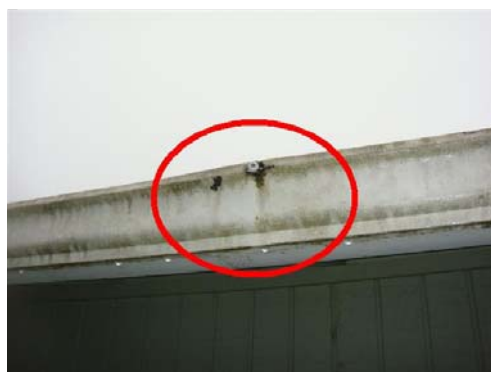
4.3 Item 6(Picture) Prior repairs

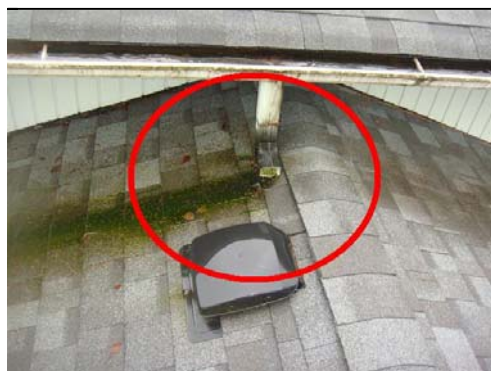
4.3 (2) Maintenance: One upper-level downspout terminated adjacent to a roof vent at the rear of the building. Recommend extending the downspout to prevent excessive amounts of water from discharging at the roof penetration at this location.

4.3 Item 8(Picture) Poor downspout termination

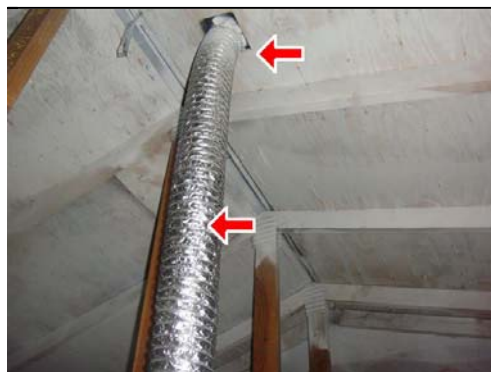
4.6 Maintenance: The ducts for the bathroom exhaust fans were not insulated in the attic and duct tape was being used to secure the ducts. Under current industry standards, these ducts should be insulated to prevent condensation build up inside the duct, using screws and zip ties to secure the ducts. Recommend replacement as an upgrade.

4.6 Item 1(Picture) Duct tape/non-insulated duct

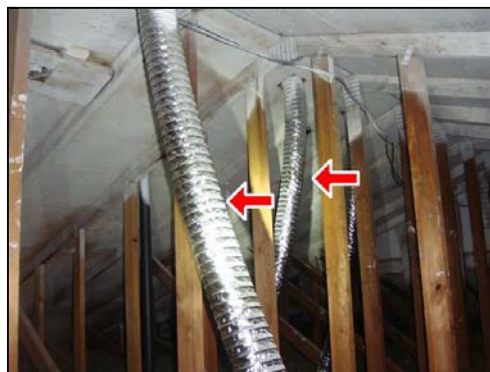
4.6 Item 2(Picture) Non-insulated ducts

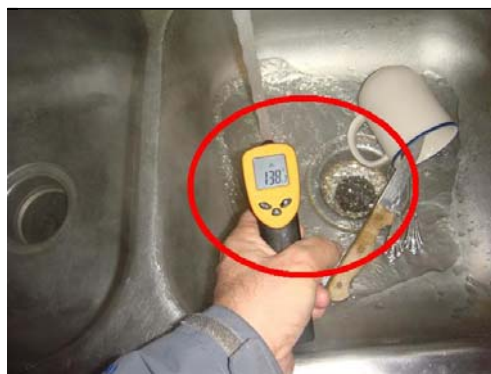
5.2 Item 1(Picture) Unit A

5.2 (1) Safety: When tested the water temperature exceeded 120 degrees in Unit A. According to the Consumer Product Safety Commission, an adult can receive a third degree burn when the water temperature is at 130 degrees. Recommend setting the temperature dial on the hot water heater to no more than 120 degrees.

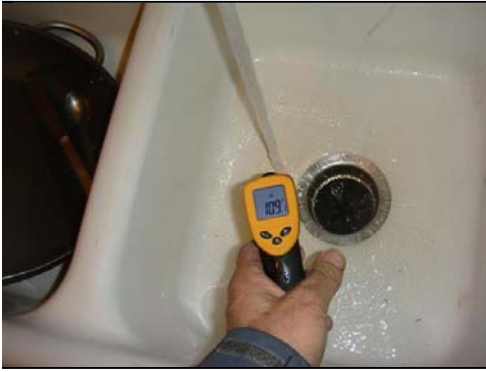
5.2 Item 2(Picture) Unit C

5.2 (4) Maintenance: When tested, the water temperature in Unit C was 109 degrees. Low water temperature may be a result of the thermostat set too low or a failed heating element. The water heater was manufactured in 2011 making it approximately 7 years of age. The average lifespan of an electric water heater is 10 to 12 years. Recommend checking the thermostat, replacing the heating element or the water heater as needed.

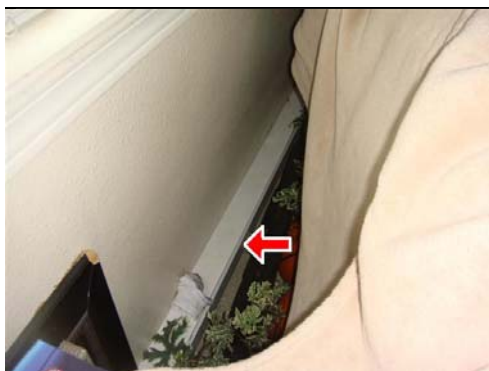
6.0 Maintenance: The baseboard heater in the living room of Unit D was not operational. Recommend repairs or replacing the heater.

6.0 Item 1(Picture) Inoperable heat in Unit D

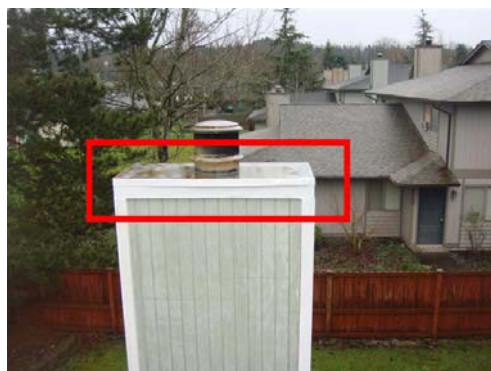
6.3 Maintenance: Standing water was noted on top of the metal chimney crowns on all three chimneys. Originally, the crowns were sloped to allow water to drain however, over time standing water may occur. Recommend repairs as needed to prevent standing water and potential water intrusion.

6.3 Item 1(Picture) Standing water

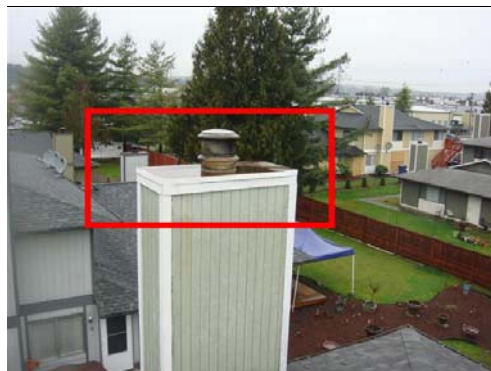
6.3 Item 3(Picture) Standing water

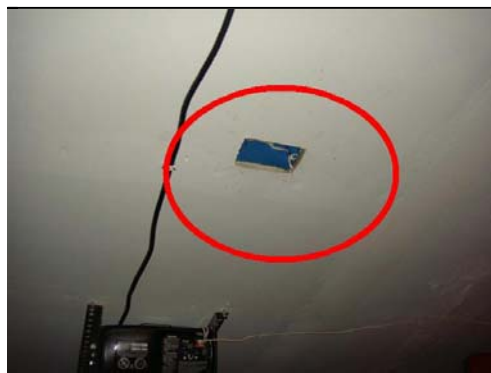
7.2 (2) **Maintenance:** A junction box cover is needed on the ceiling of the garage and Unit B.

7.2 Item 1(Picture) Cover needed in Unit B

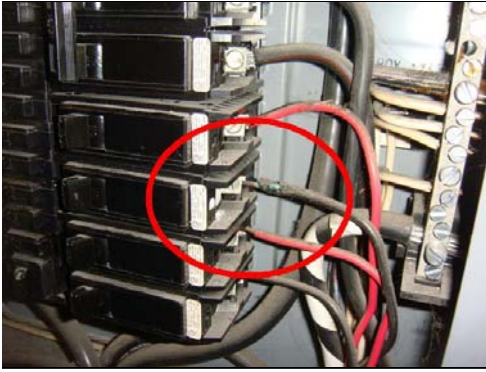
**7.2 (3) Safety :** Evidence of overheating was noted on one wire in the electrical panel of Unit B and the wire was loose to the breaker. It is recommended that a licensed electrician make repairs to prevent overheating and a potential fire.

7.2 Item 2(Picture) Overheating/loose wire

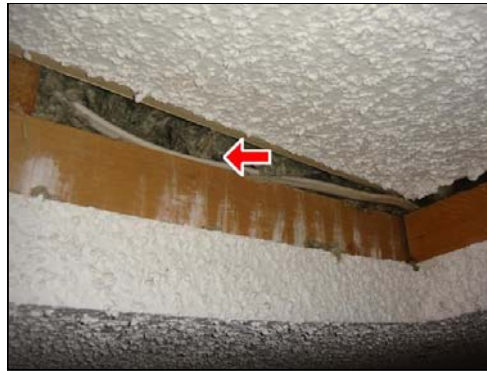
7.2 (4) Maintenance: Non metallic (NM) electrical cable was in need of protection at the attic scuttle holes. It is recommend that all cable within 6' of the entrance to the attic be protected. Also recommend securing this cable every 4.5 feet and within 12" of any box it may enter. Recommend evaluation and repairs by a licensed electrical contractor.

7.2 Item 4(Picture) Electrical subject to damage

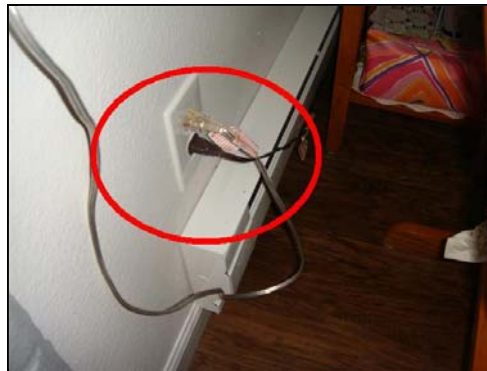
7.3 Item 2(Picture) Example of outlet above baseboard heat

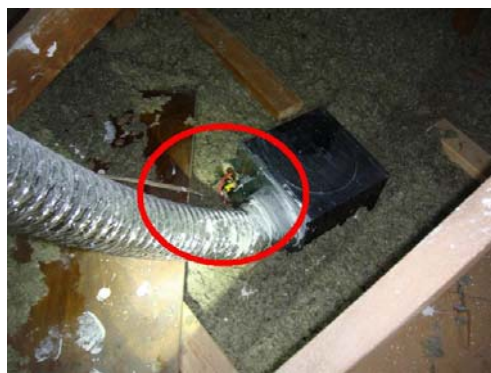
7.3 (3) Maintenance: A cover is needed on the service compartment on an exhaust fan located in the attic. Recommend the installation of a cover to prevent exposure of wires.

7.3 Item 3(Picture) Cover needed

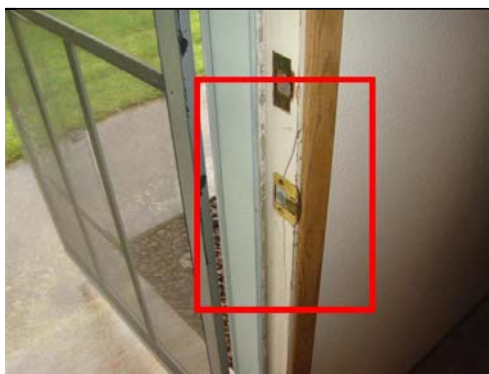
8.0 Maintenance: The jamb was split on the entry door of Unit A. Recommend repairs to the jamb as needed.

8.0 Item 1(Picture) Split jamb in Unit A

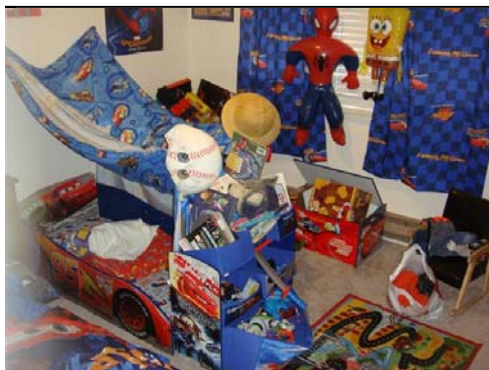
8.1 Due to personal belongings, many of the interior floors and walls were not fully visible for inspection. Recommend inspecting floors and walls after personal belongings have been removed.

8.1 Item 1(Picture) Personal belongings

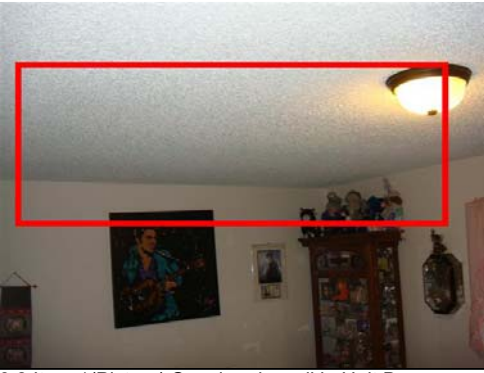
8.2 (1) Maintenance: The drywall/textured ceilings were buckling in several bedrooms of the Units. When pressed upon, the drywall is not loose however, sagging was noted. Recommend repairs to the drywall as desired.

8.2 Item 1(Picture) Sagging drywall in Unit B

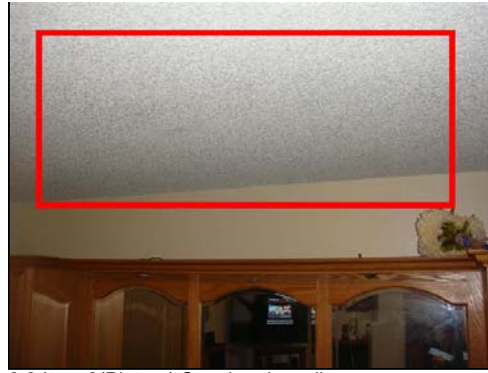
8.2 Item 2(Picture) Sagging drywall

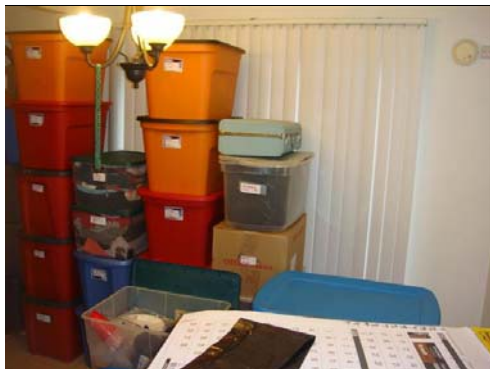
8.6 Item 2(Picture) Unit C

**8.6 (2)** Due to personal belongings, the exterior sliding door in Unit C was not accessible for inspection.

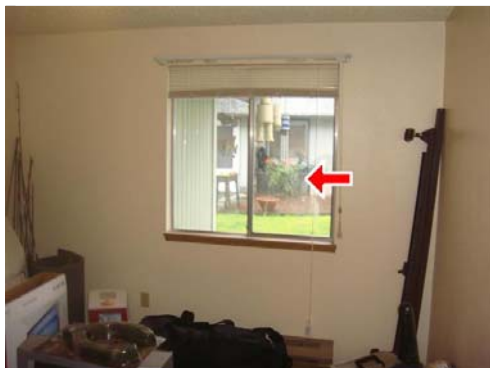
8.7 (1) Maintenance: Failed thermal seals were noted in several Units. Recommend contacting a licensed window contractor to replace the failed thermal seals as desired.

8.7 Item 1(Picture) Failed thermal seal in Unit A

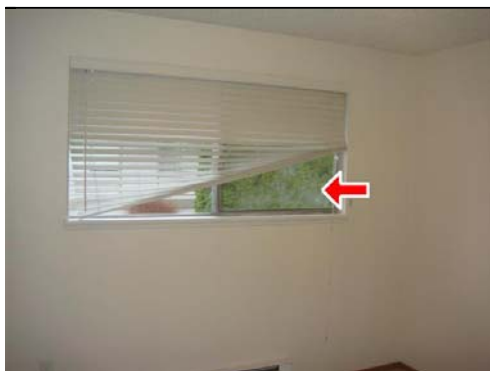
8.7 Item 3(Picture) Failed thermal seal unit C

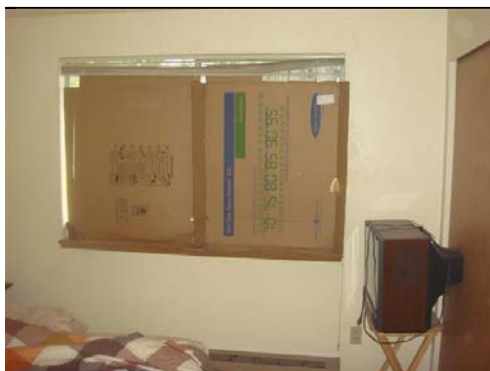
8.7 Item 4(Picture) Unit A

8.7 (2) Due to personal belongings or blocked windows, several windows in the Units were not visible for inspection.

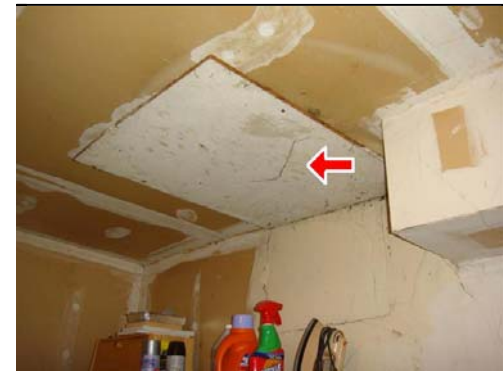
9.0 Item 1(Picture) Unit C garage

**9.0 (1) Safety :** A plywood cover has been installed over presumably a hole in the drywall ceiling in the garage Unit C. The drywall at this location provides fire safety between the garage and structure of the building. Recommend replacing the plywood with 5/8 Type X fire rated drywall by qualified person.

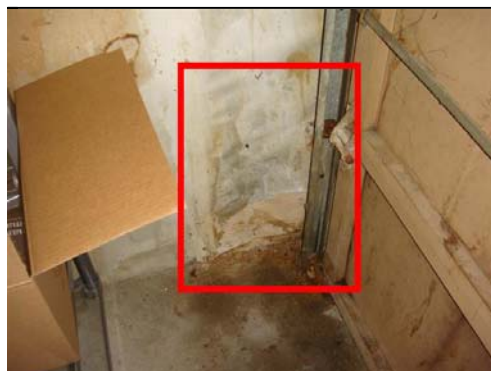
9.0 (2) Repair/Replace: Wood Destroying Organism (WDO): Evidence of water intrusion was noted on the drywall adjacent to the vehicle door in the garage of Unit C. When tested with a moisture meter, levels of moisture greater than 20% were noted on the drywall. When the moisture content of wood exceeds 20%, wood rot and mold growth will occur. When tested, the drywall crumbled, exposing active moisture ant activity. It is recommended that the drywall be removed at these locations, making repairs to the damaged exterior trim to prevent further water intrusion, reinstalling drywall by a qualified person.

9.0 Item 2(Picture) High levels of moisture/moisture ant activity

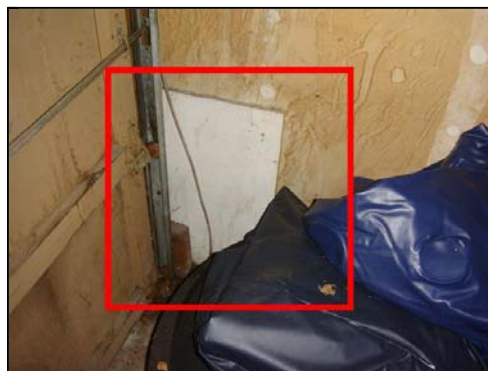
9.0 Item 3(Picture) Temporary repairs

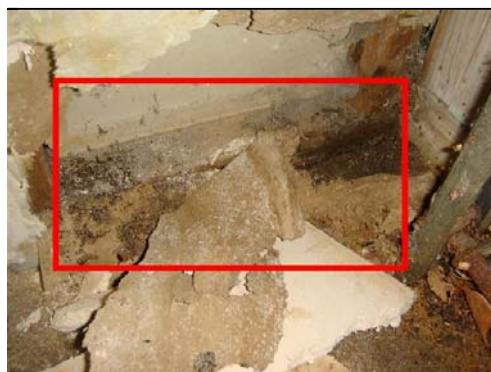
9.0 Item 4(Picture) Moisture ant activity

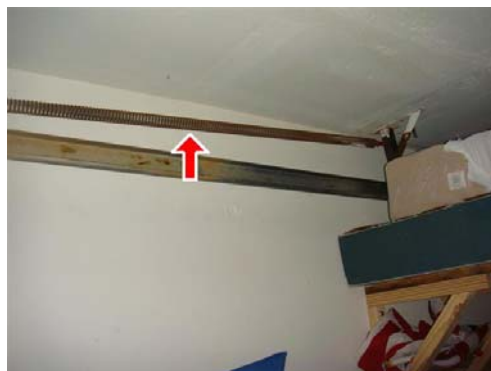
9.2 (1) Safety: No safety cable was installed inside of the garage door extension springs in all garages. The installation of a safety cable prevents the springs from becoming airborne should they break under pressure. Recommend the installation of a safety cable by a qualified garage door repair company..

9.2 Item 1(Picture) Example of cable needed

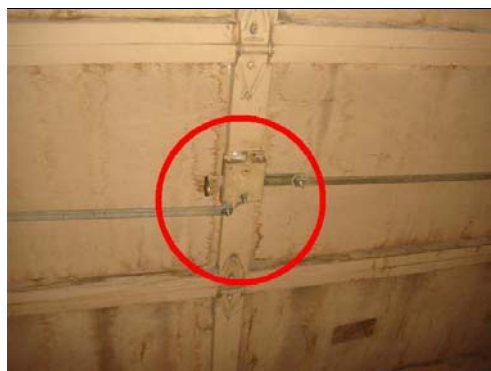
9.2 (2) Maintenance: No handle was present on the vehicle door in Unit C. This door was not tested.

9.2 Item 2(Picture) Handle missing Unit C

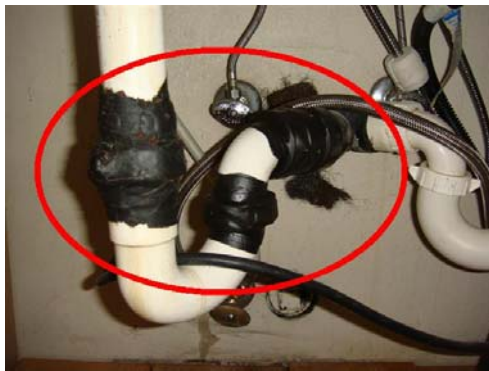
10.1.C (2) Maintenance: Nonprofessional repairs were noted on the drain beneath the sink in the kitchen of Unit C. Recommend installing a new drain and P trap by a qualified person.

10.1.C Item 2(Picture) Nonprofessional repairs

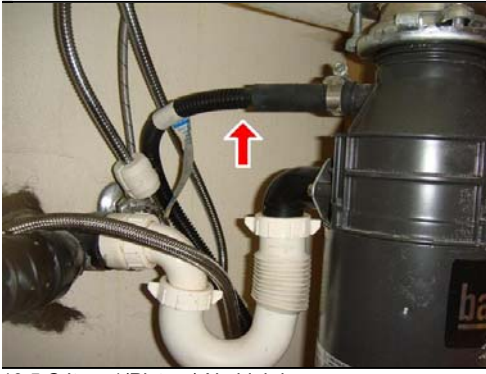
10.5.C Maintenance: No air gap or high loop was noted on the dishwasher drain line. A high loop or air gap prevents a back flow into the dishwasher should the sink become clogged. Some dishwashers have a built in check valve to prevent back flow. Recommend rerouting the drain line above the bottom of the sink, and then into the garbage disposal, consulting the manufacturers' installation instructions to determine if a check valve is installed on the unit.

10.5.C Item 1(Picture) No high loop

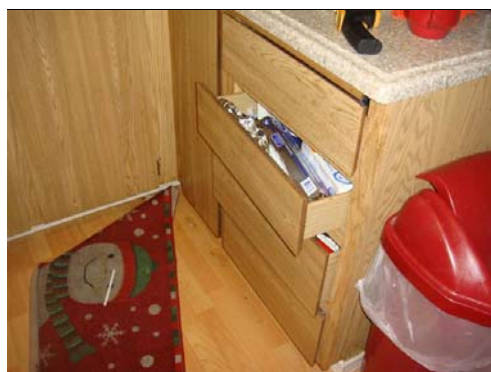
10.0.D Maintenance: Cabinets were worn and one drawer was not connected to the tracks in the kitchen. Recommend repairs to the cabinets by a qualified person.

10.0.D Item 1(Picture) Loose drawer

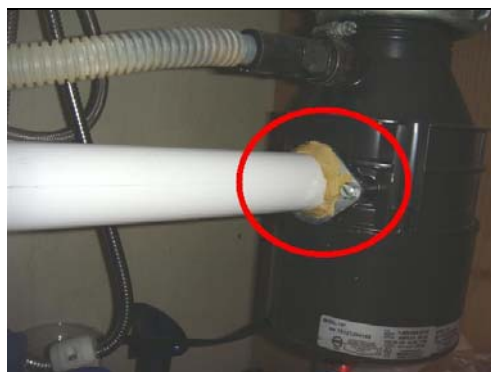
10.1.D Maintenance: Nonprofessional repairs were noted on the drain beneath the sink in Unit D. Recommend monitoring for leaks, replacing the drain as needed.

10.1.D Item 1(Picture) Nonprofessional repairs

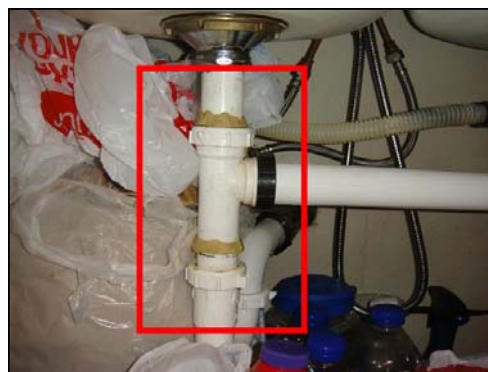
10.1.D Item 2(Picture) Nonprofessional repairs

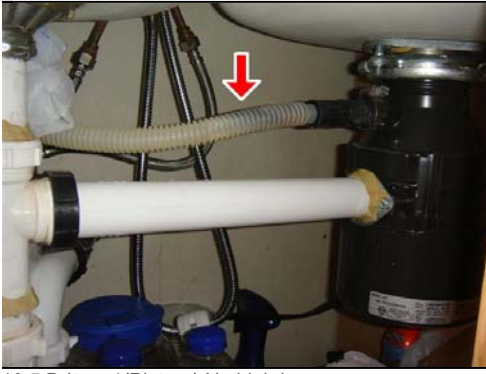
10.5.D Maintenance: No air gap or high loop was noted on the dishwasher drain line. A high loop or air gap prevents a back flow into the dishwasher should the sink become clogged. Some dishwashers have a built in check valve to prevent back flow. Recommend rerouting the drain line above the bottom of the sink, and then into the garbage disposal, consulting the manufacturers' installation instructions to determine if a check valve is installed on the unit.

10.5.D Item 1(Picture) No high loop

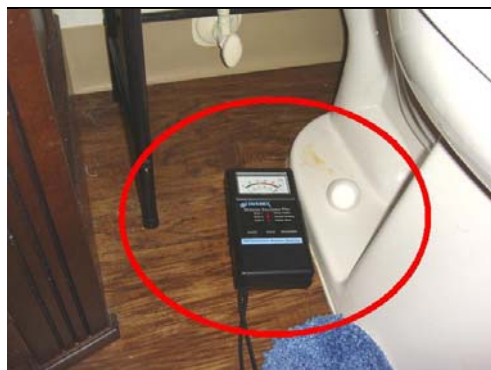
11.0.B Repair/Replace/ Wood Destroying Organism (WDO): When tested with a moisture meter high levels of moisture were noted around the toilet and beneath all of the vinyl floor in the bathroom of Unit B and visibly swelling was noted on the subfloor. When tested, the moisture content exceeded 20%. When the moisture content exceeds 18% wood rot and mold growth will begin. I was unable to determine the extent of damage if any to the substructure beneath the floor covering. Recommend removal of the toilet to view subfloor repairing all damaged wood that may be exposed, reinstalling the toilet with a new wax ring.

11.0.B Item 1(Picture) High levels of moisture

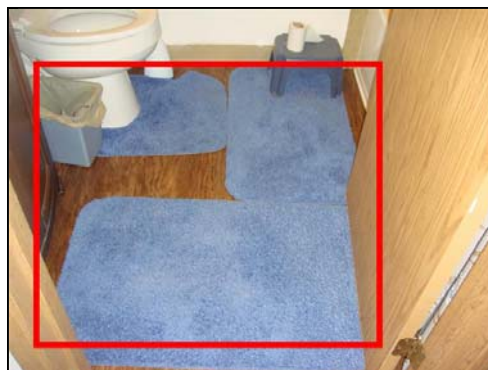
11.0.B Item 2(Picture) High levels of moisture

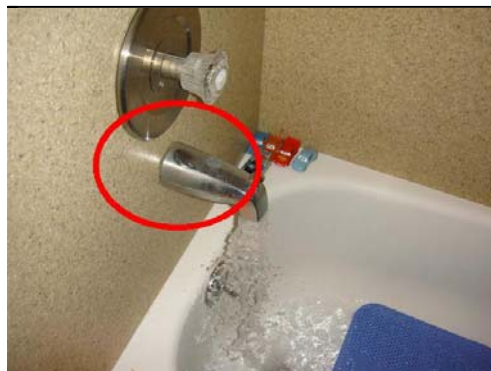
11.4.B (1) Maintenance: Recommend installing silicone between the tub spout and the tub enclosure to prevent moisture intrusion.

11.4.B Item 1(Picture) Silicone needed

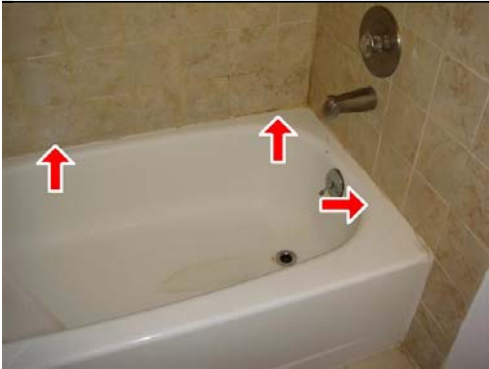
- 11.1.C Maintenance: No drain stop was installed on the sink. Recommend installing a drain stop as desired.
- 11.4.C Maintenance: The caulking was worn on the tub surround. Recommend removal of worn caulking, reinstalling caulking to prevent water intrusion.

11.4.C Item 1(Picture) Worn tub surround

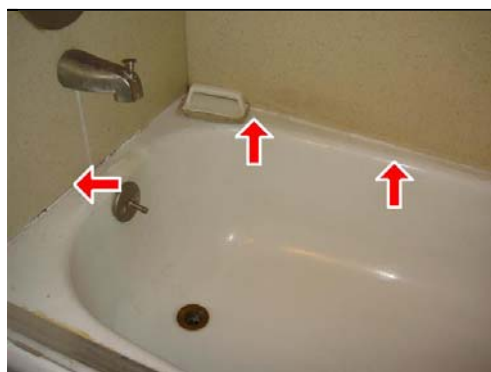
11.4.D (1) Maintenance: The caulking was very worn between the tub and surround. Recommend removal of worn caulking, reinstalling caulking to prevent water intrusion.

11.4.D Item 1(Picture) Worn tub surround
