Inspection Report

1234 Main St.
Auburn WA 98002

Coastline Home Inspections

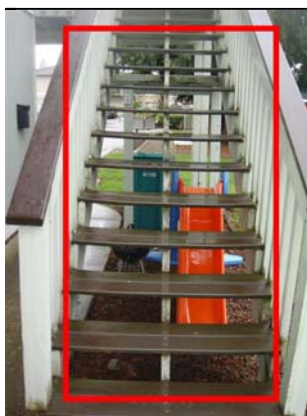
1.1 (1) Safety: The space was too large between each riser on exterior stairs. It is recommended that these openings be blocked to prevent injury to small children. Recommend repairs by a qualified person.

1.1 Item 1(Picture) Blocking needed

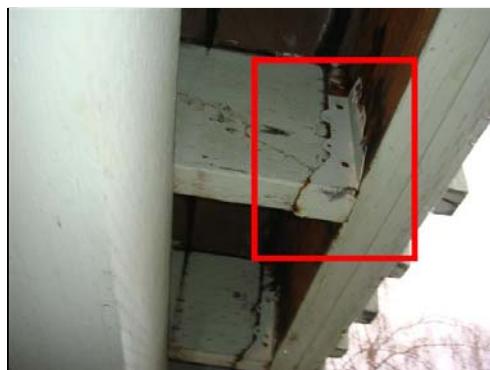
1.1 (2) Repair/Replace: Safety : Inadequate fasteners were noted on many joist hangers at the front deck. According to the manufacturer, fasteners are required at all holes supplied by the manufacturer of the bracket. Also, screws were being used on brackets at several locations. Screws are not permitted to be used at these locations as they do not contain the same shear strength as a nail. Also, wood rot was noted on several floor joists of this deck. Newer pressure-treated wood has been sistered to the rotting portions however, wood rot will continue to grow and eventually begin to damage the pressure-treated lumber. The top of the stair stringers are beginning to pull loose creating a fall hazard. It is recommended that a licensed contractor familiar with deck construction be contacted to make repairs to the deck and stairs, making all repairs to current industry standards to prevent accidental injury.

1.1 Item 3(Picture) Example of fasteners needed

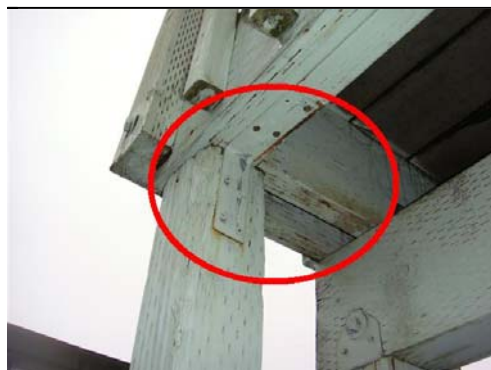
1.1 Item 4(Picture) Screws used

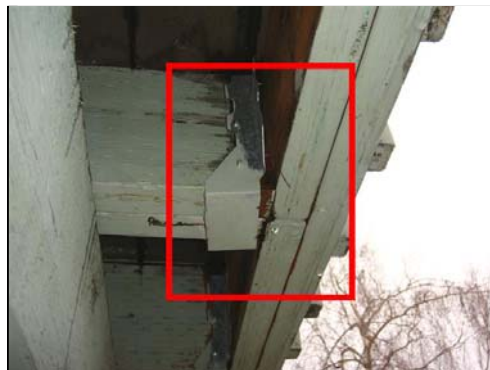
1.1 Item 11(Picture) Example of fasteners needed

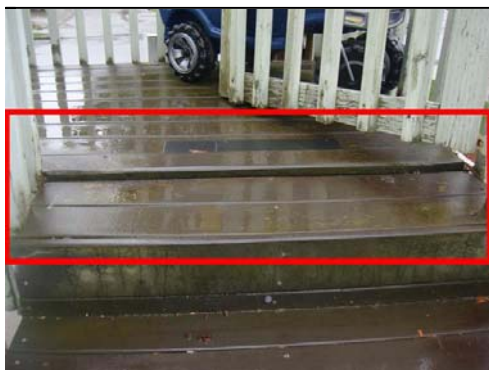
1.1 Item 12(Picture) Evidence of settling where stairs meet deck

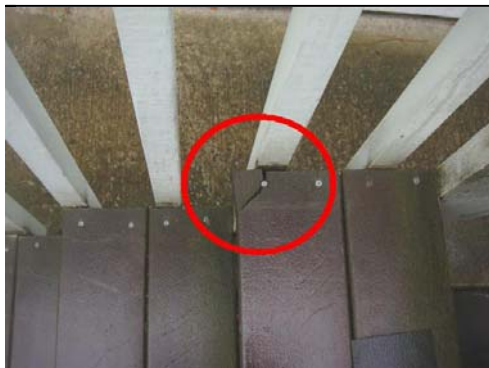
1.1 (4) Maintenance: Damage was noted to many composite stair treads. Recommend replacing all damaged treads by a qualified person.

1.1 Item 15(Picture) Example of cracked composite stair treads

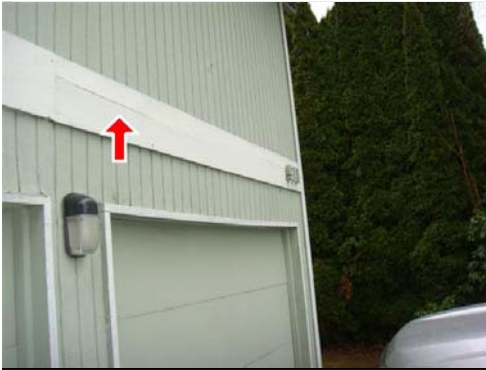
2.0 (1) Repair/Replace: Wood Destroying Organism (WDO): Wood rot was noted on trim and wall cladding at many locations around the perimeter of the home (see photos). Also, the trim was in need of paint at many locations. A board by board inspection is outside the scope of a home inspection however, it is recommended that a licensed siding contractor replace all damaged areas noted in the report and a complete inspection of the exterior of the building, including potentially removing belly band boards between levels of the home and along the ground floor, replacing any damaged siding that may be discovered, prepping, priming and painting the exterior siding and trim as needed. Damaged siding was also noted at all three chimney flashings. When damage occurs at these locations, water intrusion may occur around the chimney flashings.

2.0 Item 1(Picture) Split trim

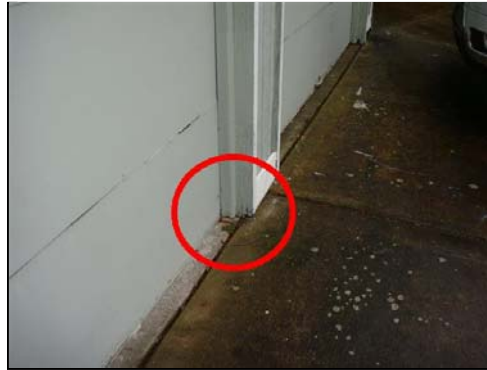
2.0 Item 2(Picture) Wood rot

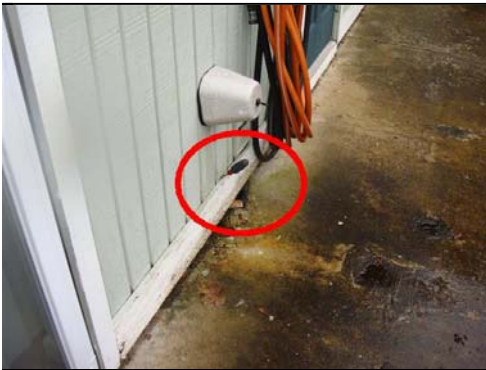
2.0 Item 11(Picture) Wood rot

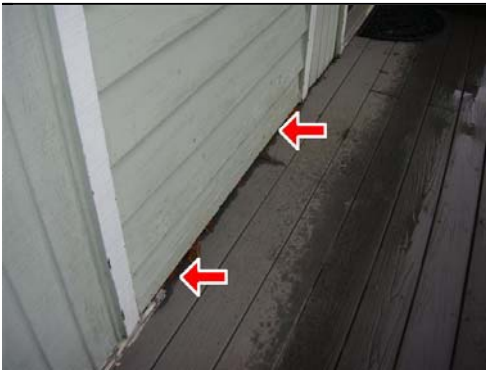
2.0 Item 13(Picture) Wood rot

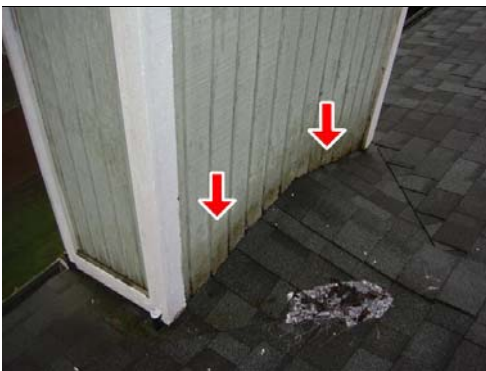
2.0 Item 15(Picture) Wood rot

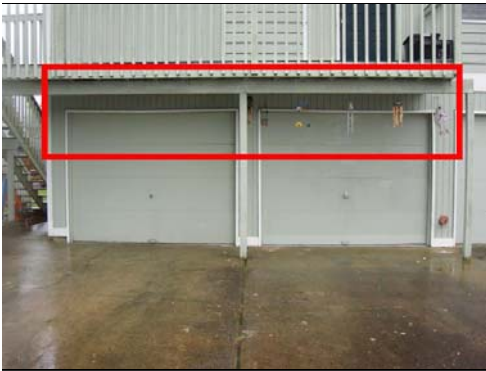
2.0 (3) Monitor: Maintenance: Minor sagging was noted on the header boards above the two left garage doors. Recommend monitoring for excessive movement, making repairs to the headers as needed.

2.0 Item 19(Picture) Sagging headers

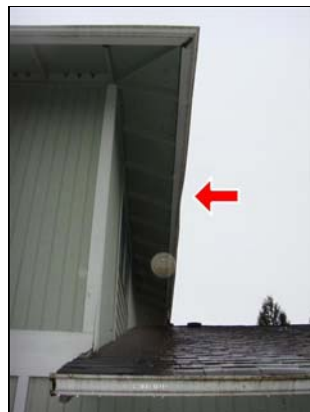
4.3 (1) Repair/Replace: Wood Destroying Organism (WDO): Gutters and downspouts were sagging, leaking and full of water/improperly sloped at many locations around the building. It is recommended that a licensed gutter contractor be contacted to install new gutters on the building to prevent further sagging and damage to the fascia boards and wall cladding of the home.

4.3 Item 4(Picture) Damaged gutter

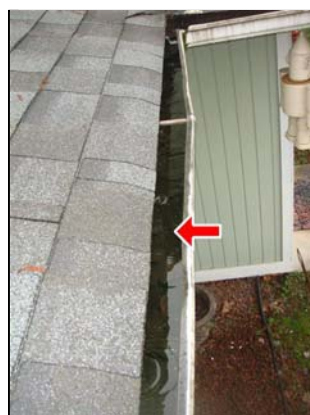
4.3 Item 7(Picture) Standing water

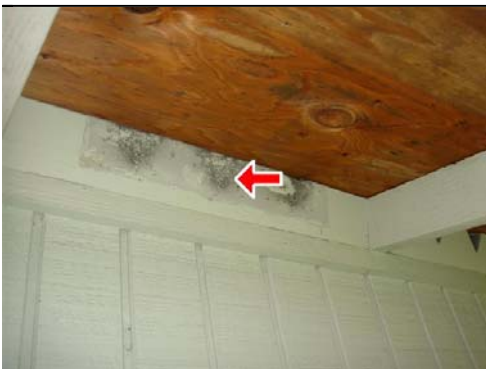
4.5 (1) Maintenance: Small meshed screens have been installed on the eaves vents at several locations. Recommend installing different screens to ensure sufficient ventilation is present for the attic.

4.5 Item 1(Picture) Minimal ventilation

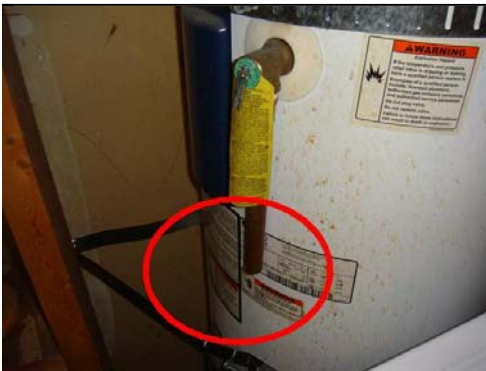
5.2 Item 3(Picture) Unit C

5.2 (5) Maintenance: The discharge pipe for the pressure relief valves are too short or missing on several water heaters. Discharge pipes should terminate to within 6 inches of the ground or to the exterior of the building. Recommend repairs by a qualified person.

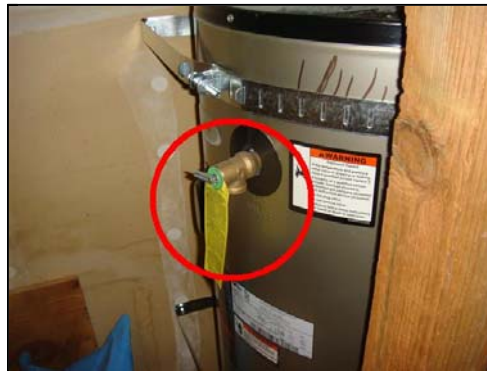
5.2 Item 4(Picture) No discharge pipe on Unit A

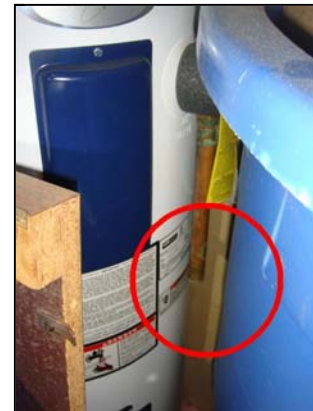
5.2 Item 5(Picture) Discharge too short in Unit D

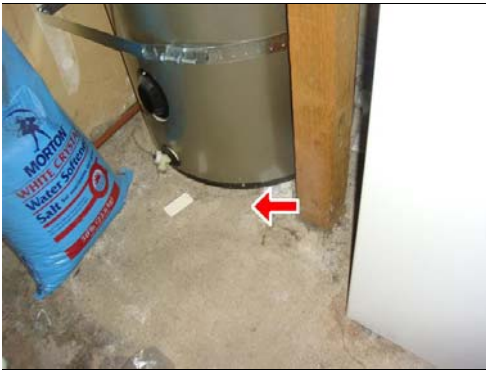
5.2 (6) Maintenance: The electric water tank in Unit A was resting on the cement floor. When installed in this manner it is recommended that a thermal barrier be installed to prevent heat loss at the heater. Recommend the installation of an insulated pad with a minimal thermal resistance of R-10 under the water heater.

5.2 Item 6(Picture) Thermal barrier needed in Unit A

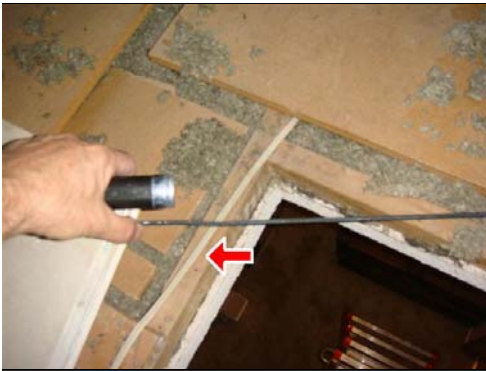
7.2 (4) Maintenance: Non metallic (NM) electrical cable was in need of protection at the attic scuttle holes. It is recommend that all cable within 6' of the entrance to the attic be protected. Also recommend securing this cable every 4.5 feet and within 12" of any box it may enter. Recommend evaluation and repairs by a licensed electrical contractor.

7.2 Item 3(Picture) Electrical subject to damage

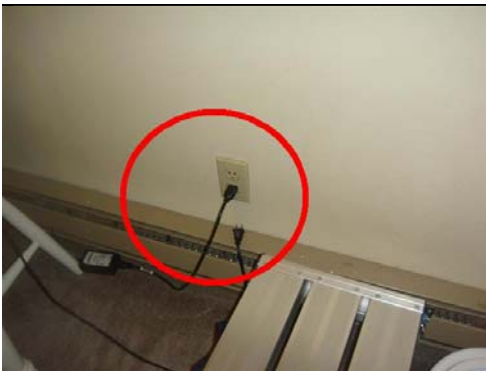
**7.3 (1) Safety:** Electrical outlets were installed over baseboard heaters at several locations in all Units. It is not recommended that outlets be installed in this manner as the cords of plugged in devices will hang in front of the heater. Recommend rerouting cords to prevent contact with the heater.

7.3 Item 1(Picture) Example of outlet above the baseboard heat

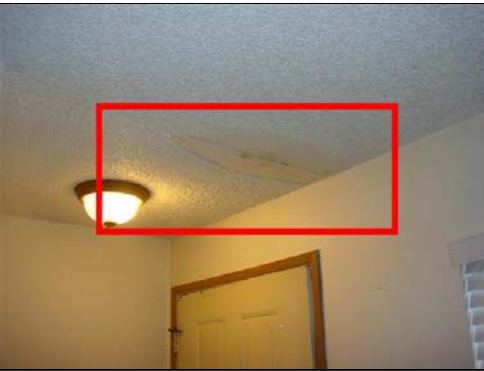
8.2 (2) Monitor: Evidence of a prior leak was noted on the ceiling of Unit C. When tested with a moisture meter, no high levels of moisture were detected at the time of inspection. Recommend confirmation from the seller regarding prior leaks at this location.

8.2 Item 3(Picture) Evidence of prior leak in Unit C

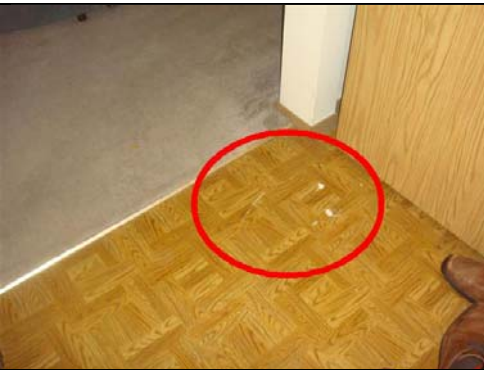
8.4 (1) Repair/Replace: Overall, the floor coverings in the home, primarily carpeting and vinyl, are very worn, soiled or damaged. Recommend budgeting for replacement of the floor coverings in the home as needed.

8.4 Item 1(Picture) Damaged vinyl flooring in Unit A

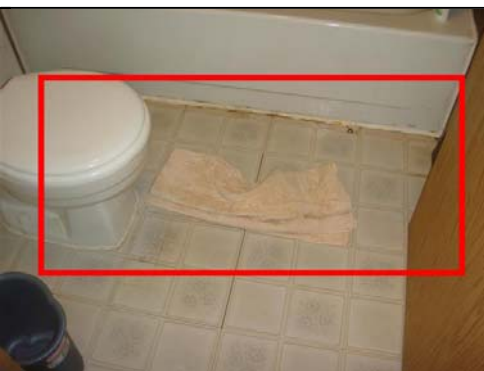
8.4 (2) Repair/Replace: Evidence of water intrusion behind the self-adhesive floor tiles were noted in the bathroom of Unit A. Recommend replacing the vinyl flooring at this location by a qualified person.

8.4 Item 2(Picture) Unit A bathroom

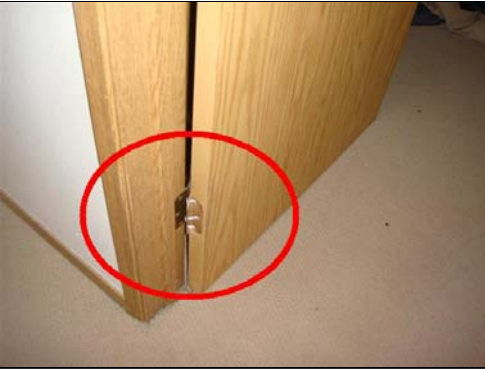
8.5 (2) Maintenance: One hinge was disconnected on the door in Unit C. Recommend repairs to the door or jamb as needed.

8.5 Item 1(Picture) Disconnected hinge in Unit C

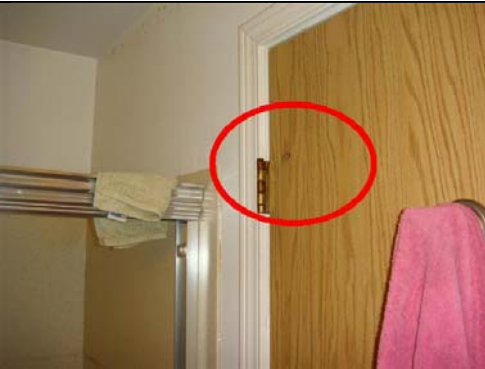
8.5 (3) Maintenance: A hole was noted in the bathroom door of Unit D. Recommend repairs to the door as needed.

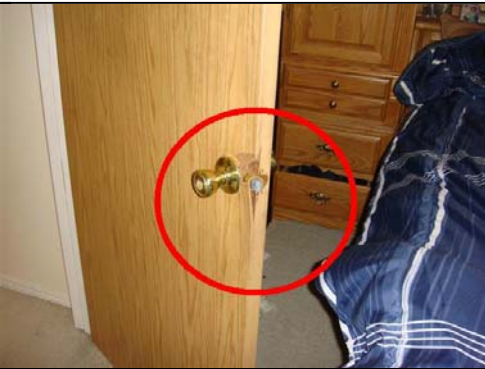
8.5 (4) Maintenance: The door was damaged in the master bedroom of Unit D. Recommend replacing the door by a qualified person.

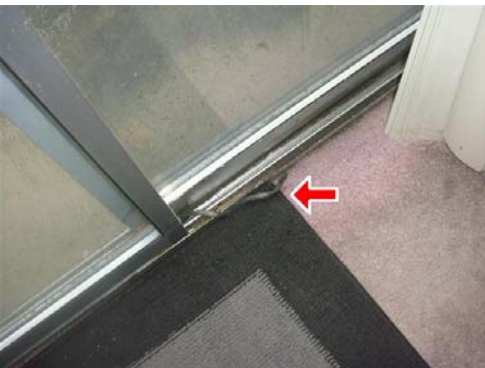
**8.6 (1) Repair/Replace:** The weather seal was damaged and the exterior door was difficult to operate in Unit A. Recommend repairs or replacing the door as needed

8.6 Item 1(Picture) Damaged weather seal Unit A

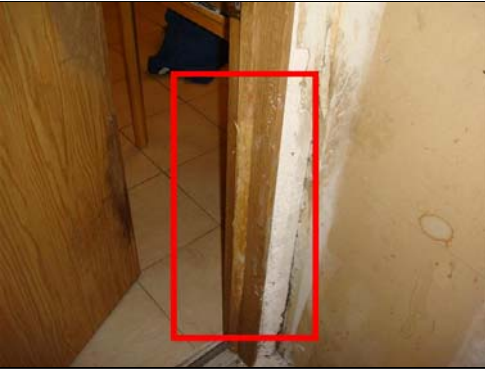
9.3 (1) Maintenance: The jamb was damaged on the door to the interior in Unit C. Recommend replacing the jamb by a qualified person.

9.3 Item 1(Picture) Damaged jamb in Unit C

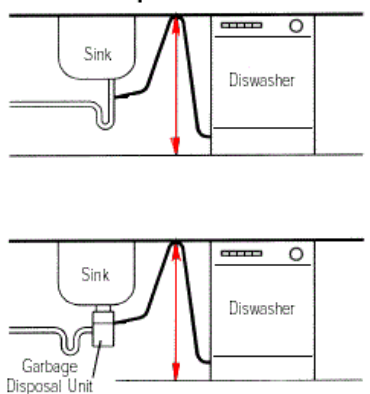
10.5.A Maintenance: No air gap or high loop was noted on the dishwasher drain line. A high loop or air gap prevents a back flow into the dishwasher should the sink become clogged. Some dishwashers have a built in check valve to prevent back flow. Recommend rerouting the drain line above the bottom of the sink, and then into the garbage disposal, consulting the manufacturers' installation instructions to determine if a check valve is installed on the unit.

**10.5.A Item 1(Picture) Example of high loop**

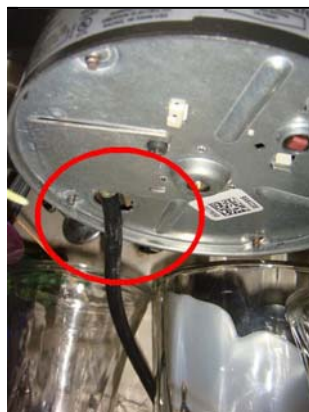
10.6.B Maintenance: The food disposer wiring is missing a cord connector (anti-strain device). Recommend installing a proper connector.

10.6.B Item 1(Picture) Connector needed

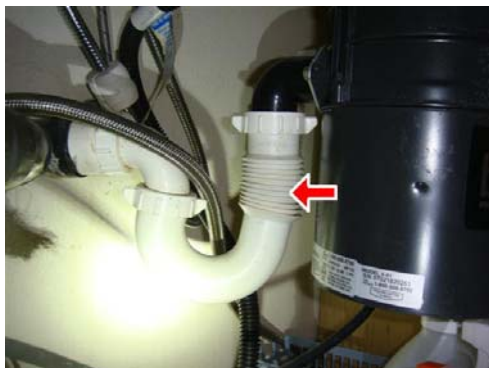
10.1.C (1) Maintenance: A ribbed, flexible drain is being used beneath the kitchen sink. Under current industry standards, all drain material must be smooth walled to prevent frequent clogging. Recommend repairs by a qualified person.

10.1.C Item 1(Picture) Ribbed drain

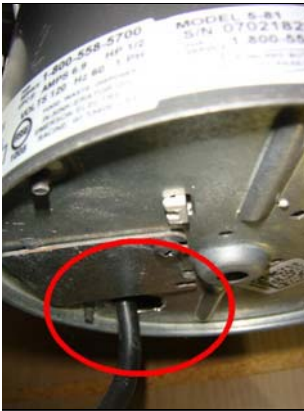
10.6.C Maintenance: The food disposer wiring is missing a cord connector (anti-strain device). Recommend installing a proper connector.

10.6.C Item 1(Picture) Connector needed

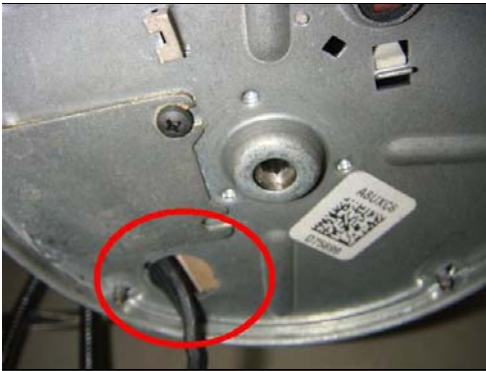
10.6.D (1) Maintenance: The food disposer wiring is missing a cord connector (anti-strain device). Recommend installing a proper connector.

10.6.D Item 1(Picture) Connector needed
